Expansion of Eglise Évangélique Luthérienne

Balagué, Haiti

June 28, 2017

Preliminary Inspection of the Church Building

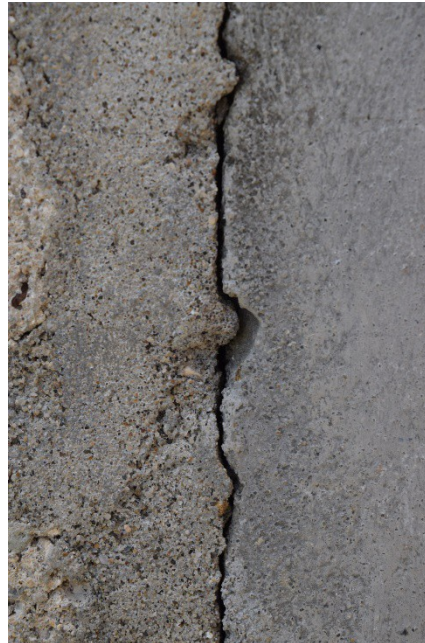
One of the first things that I noticed is there was no bonding between the columns and the infill block walls, as illustrated in this photo. In this photo, the block wall has been plastered.

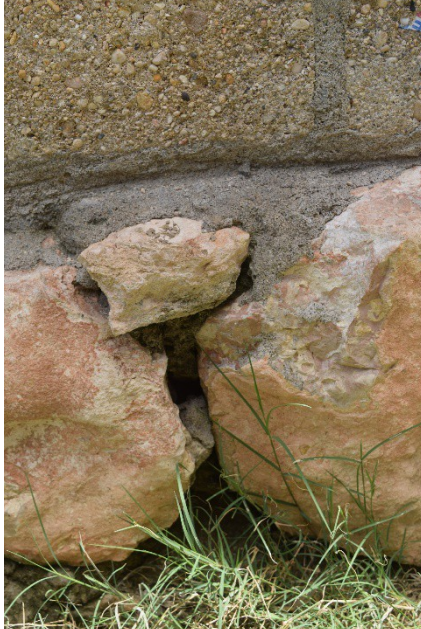
The foundation was made of fairly large rock that were mortared together. However, some of the mortar was weak and had eroded away.

Photo was taken at the rear of the building, on the left side, and illustrates how the block wall is not tied to the column, how the block in the wall are not bonded together with mortar, but just held apart with mortar, and how the mortar between the rock of the foundation has eroded. There is also erosion on the lowest concrete block shown in the photo. In other areas of the building there was much more erosion in some of the concrete block.

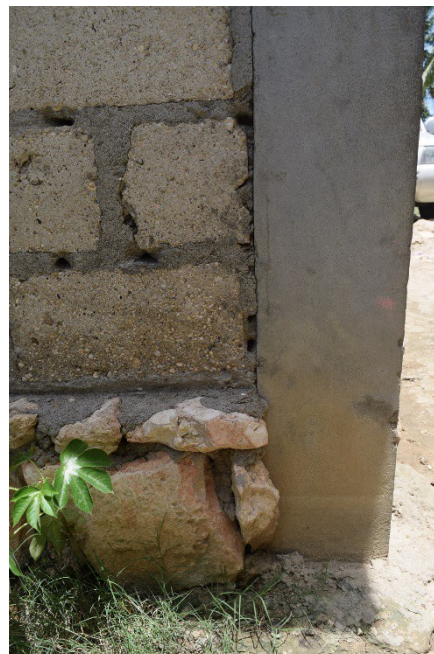
One of the leaders of the church told me

that the columns were set into the ground approximately two thirds of a meter. That is approximately 26 inches.

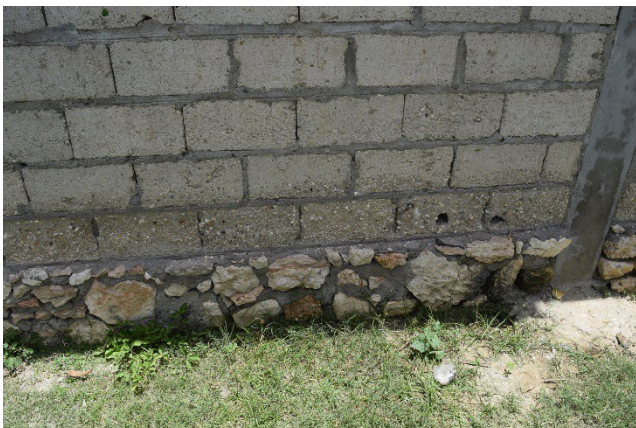
This photo illustrates severe erosion on the lower row of concrete block on the right side of the building.

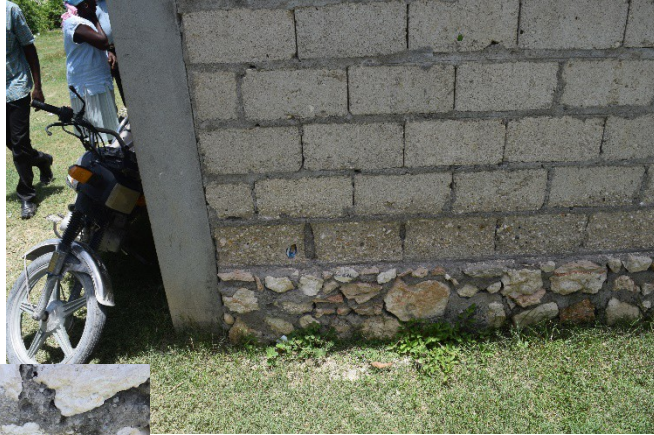
This photo illustrates the same thing near the front of the right side of the building and shows the front column.

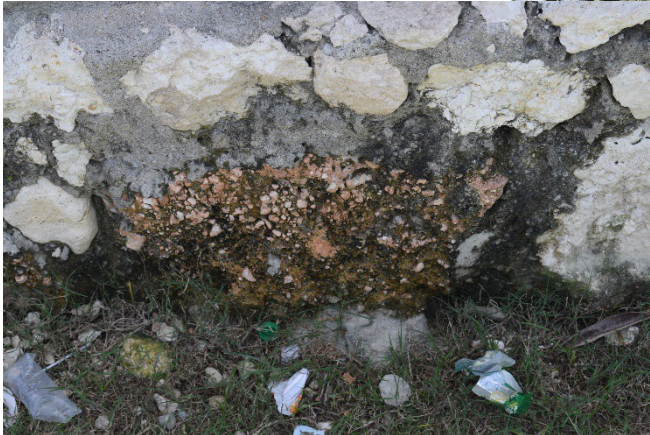
This photo illustrates erosion of one of the large stones in the foundation. Combined with the erosion of the mortar between other stones, it demonstrates that the foundation should be plastered to protect it.

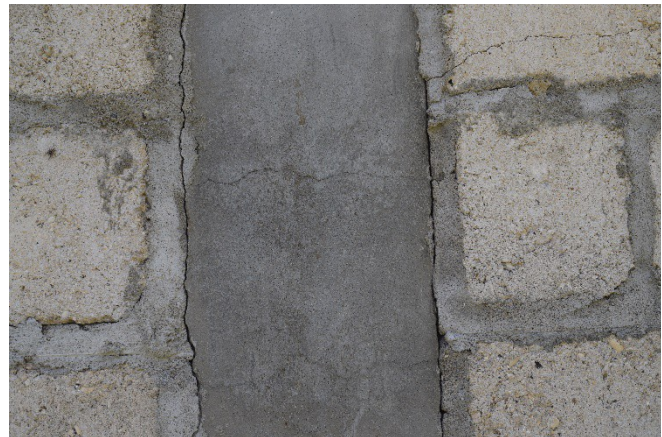
This photo shows vertical cracks between the column and the block wall. It also shows horizontal cracks in the column. Based on the location of the horizontal cracks, it appears that they are caused by the rebar wraps around the vertical rebar, and that the wrapping rebar is oxidized and has expanded slightly. If the oxidation continues, and it will, in time the column will have severe horizontal and vertical cracks.

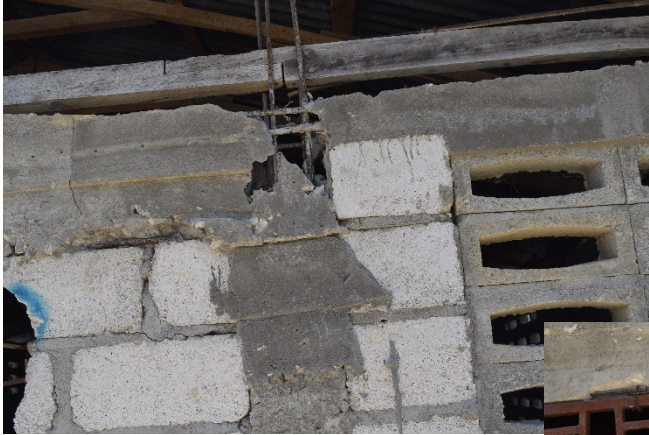
This photo was taken at the front of the building. It illustrates that a column was placed into the wall as confined masonry and met a beam that was poured

across the top of the wall. The concrete left gaps so neither the beam nor the column is effective. Further, the photo illustrates that the wooden top plate is not attached to the wall for at least one meter.

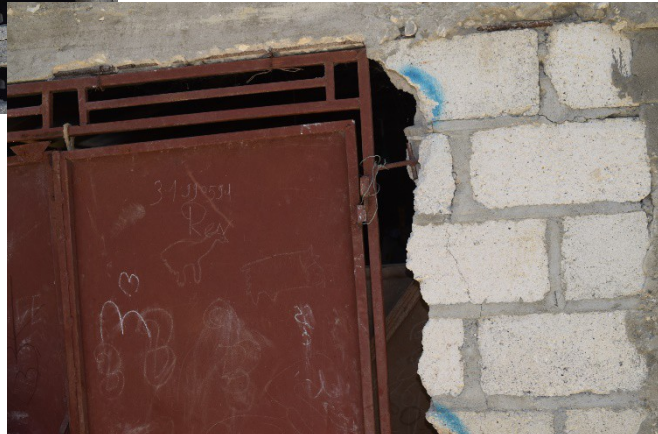
This photo illustrates the upper right corner of the front door of the church. The door is contained in a steel frame, and the steel frame was anchored into the concrete block wall. Since the concrete block were weak, and the cells were not filled with concrete, movement of the frame caused the concrete block to break. The only thing holding the door frame in place is that it is sitting on the slab, and it is nominally attached to the beam above it.

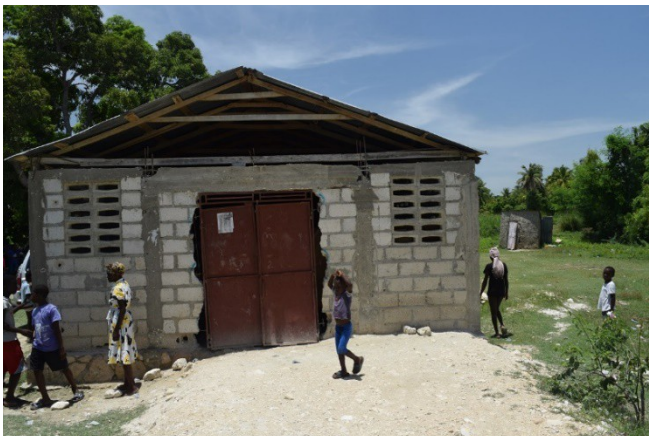
This photo illustrates several things.

1. The concrete beam across the front of the building is not continuous.

2. There is no horizontal beam halfway up the wall.
3. There are no columns on either side of the doorframe.
4. The wood truss and metal roof are sitting on top of the walls and not

attached substantially to the walls.

5. The overhang from the roof is minimal. This reduces the impact of high winds, which could tear the roof off, but it increases the erosion of low-quality concrete block that are used in building the walls.

6. The gable end is open (closed on the other end), so there is a larger updraft when winds hit the front of the church.

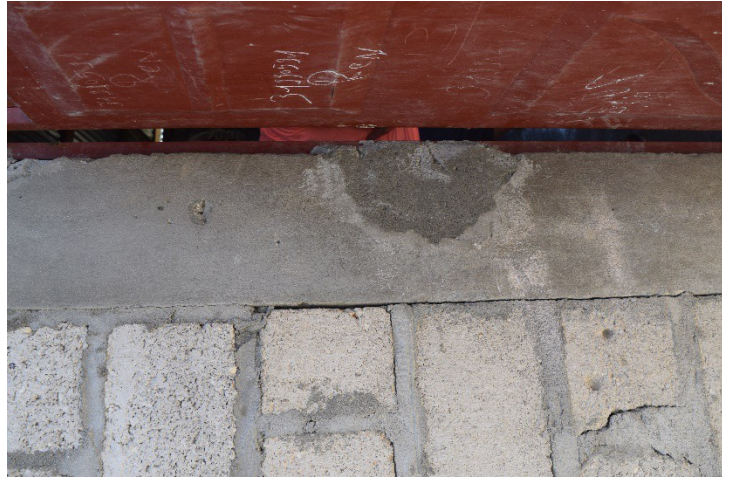
This is the side door on the left side of the building. In this case the metal door frame is attached to a column. The quality of the concrete in the column was not sufficient to hold the door frame in place, so repairs had to be made.

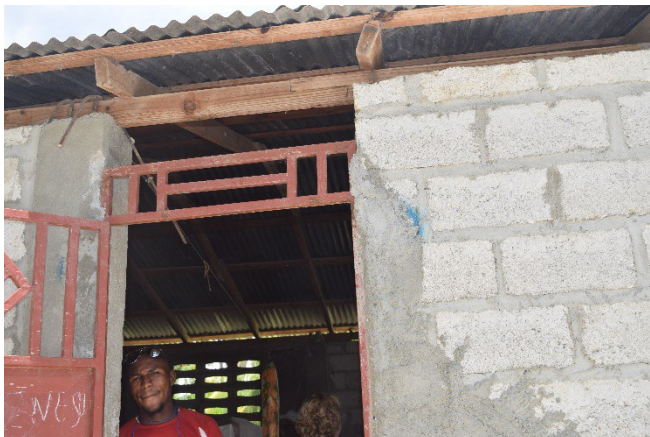
The upper portion of the same door frame. On the latch side of the door frame, repairs have been made because movement of the door frame had broken the block which were to hold it in place. There is no concrete beam above the doorway to help hold the door frame in place. A wooden beam rests on

the top of the wall around the exterior of the church. Wood trusses in the metal roof are attached to the nominally 5 cm by 10 cm wooden beam.
