Concrete and Building in Haiti

Report 1

By: Herb Nordmeyer

September 26, 2013

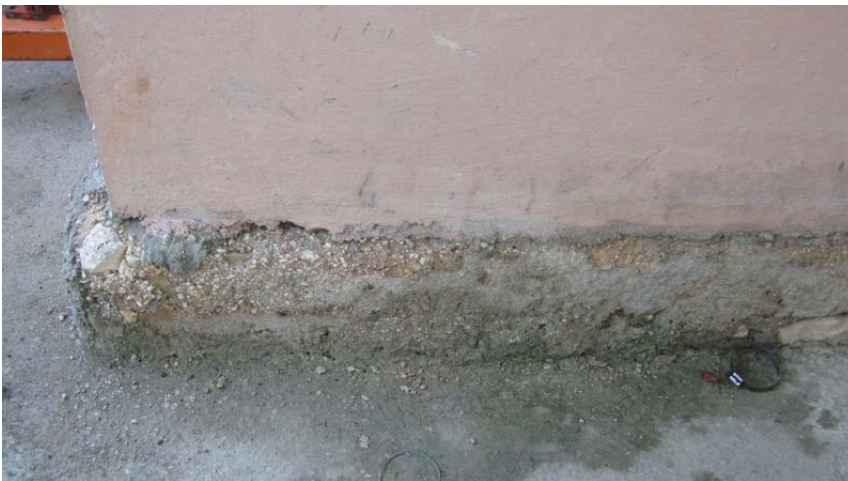
2 After a few years, many concrete foundations start to deteriorate.

Often the concrete in foundations starts to deteriorate within a few years. This can be caused by the clay in the sand, the lack of Portland cement in the concrete, or a number of other factors.

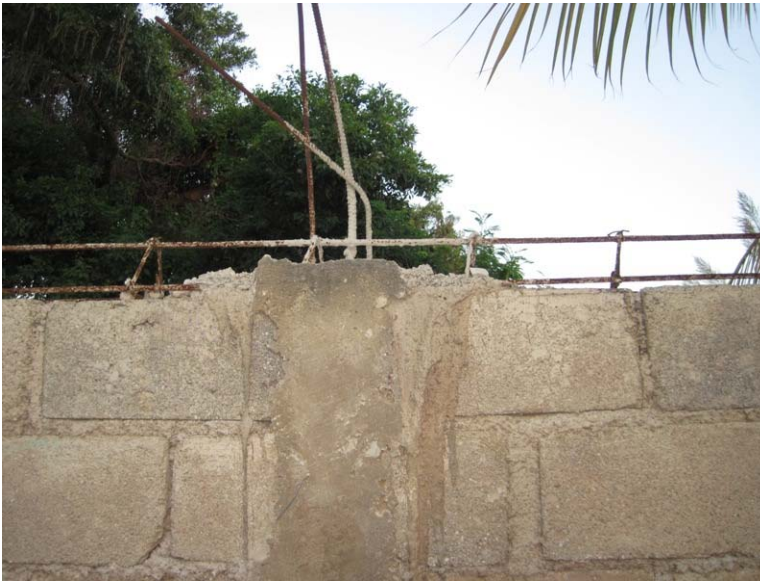
3 Typical lightly-reinforced framework with masonry infill.

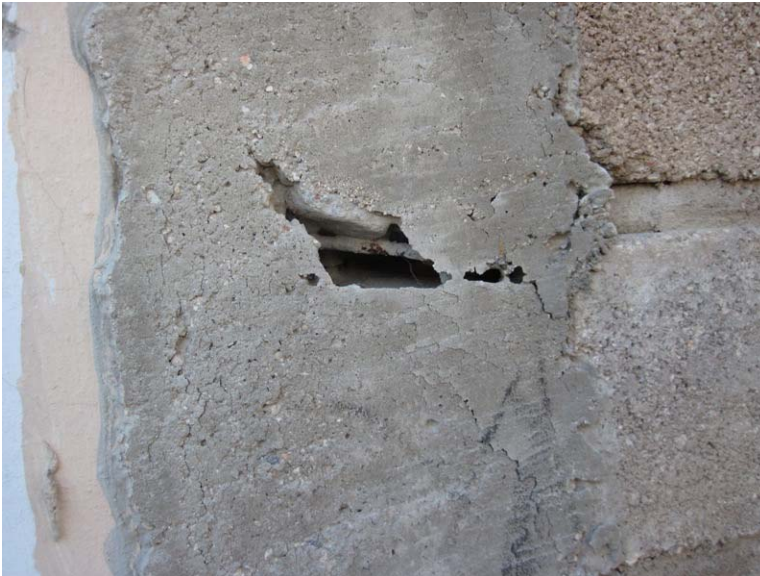
4 Regularly, the columns are not rodded enough to get the concrete adequately consolidated.

Concrete is poured in from the top and is usually rodded. However, the rodding is frequently insufficient to fill all of the voids in the column. After the concrete cures, the boards are removed. The columns are usually 10 cm or 15 cm square for fences and 15 cm square for single story houses.

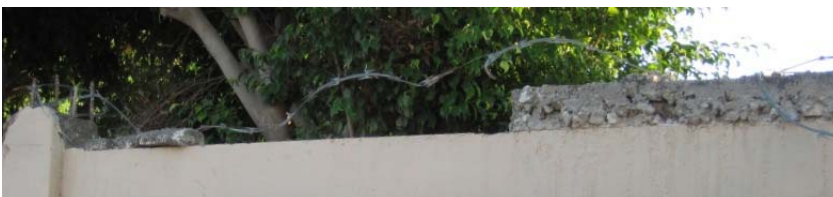
5 The capping beam on this wall did not remain in place.

Sometimes when the capping beam is installed, it does not stay in place.

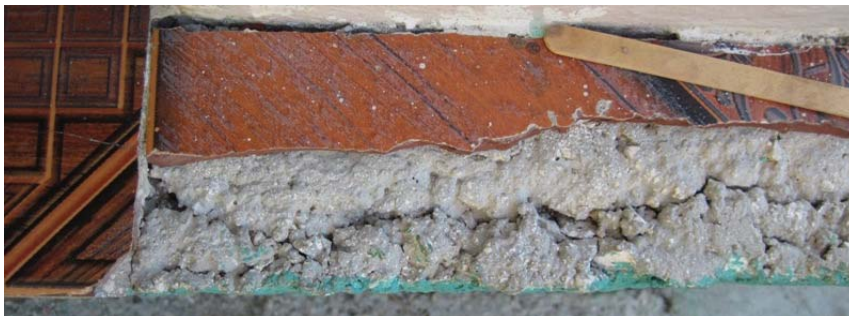
6 Inadequate bedding mortar resulted in ceramic tile failure.

Floor tile are used to hide imperfections in concrete floors. If an adequate bedding mortar is not used, the tile are likely to break.

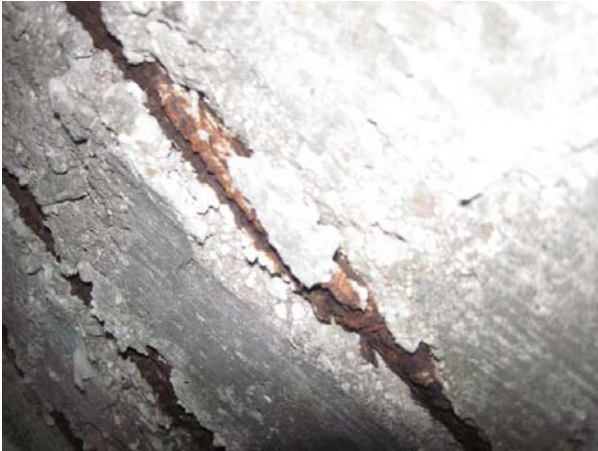
7 Chlorides are attacking the rebar on the underside of this concrete roof.

Much of the well water in lower elevations of Haiti is brackish. This brackish water is used to produce much of the concrete. The chlorides in the water attack the steel rebar and cause the rebar to corrode. As a result of the corrosion, the rebar expands, which in turn causes the concrete to crack.

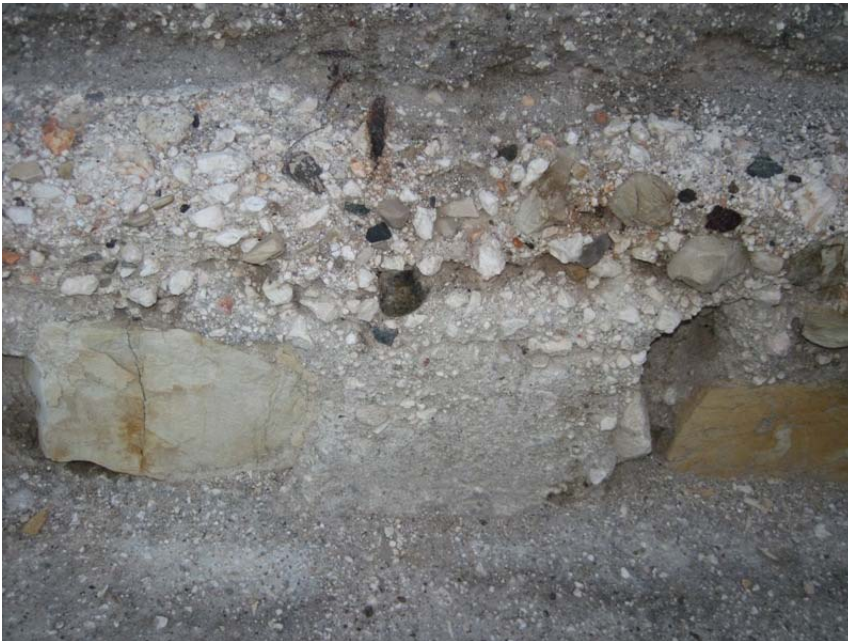
8 Some of the sands that are commonly used contain as much as 20% clay.

Another factor that impacts the quality of the concrete is the fine aggregate. Much of it has not been washed, and I observed some sand that contained up to 20% clay.

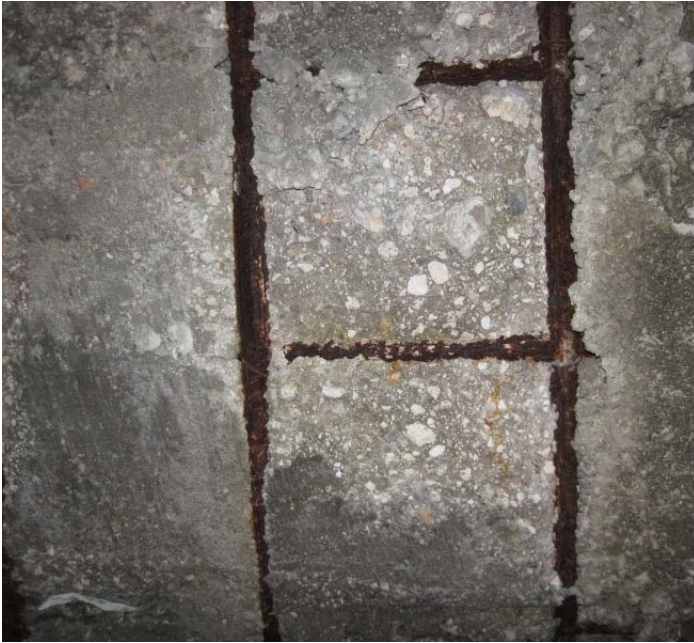
9 The rebar on the underside of this roof was not covered adequately.

Placement of rebar is often not optimal.

Many times the rebar is exposed on the surface rather than being imbedded in the concrete at a depth of three times the diameter of the rebar.

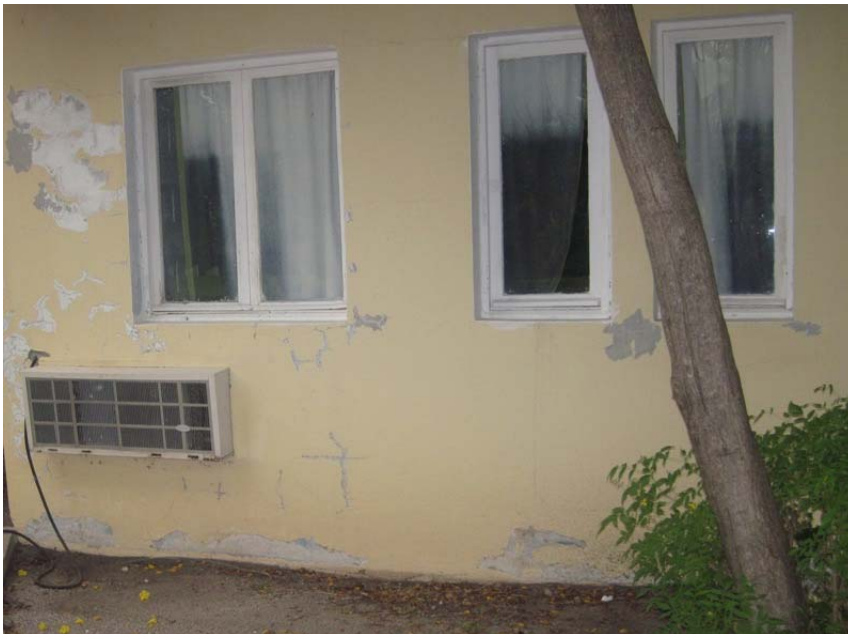
10 Peeling paint caused by water in the walls is common, even in more expensive structures.

Many of the concrete walls had peeling paint, which indicated that water was coming out of the wall.

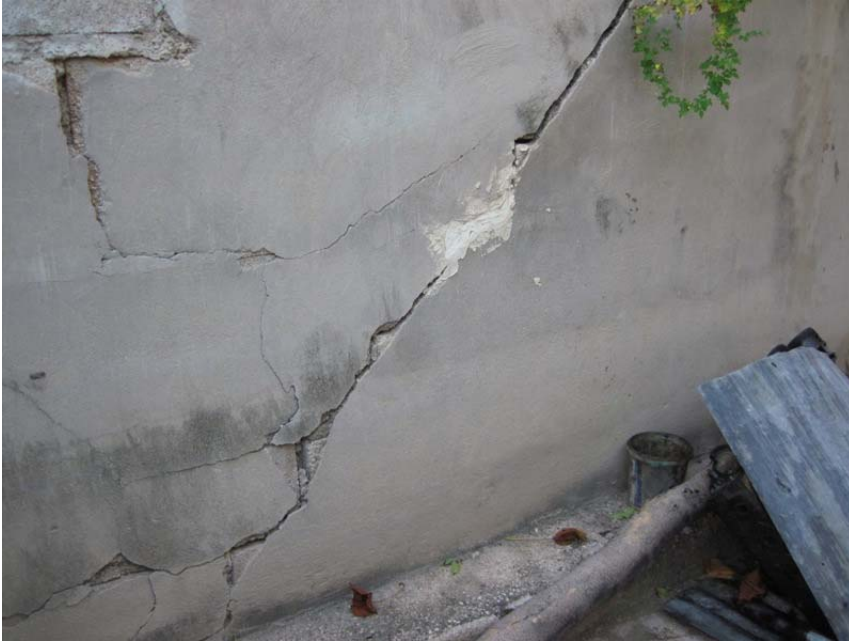
11 Many walls had strong angle cracks.

Many of the concrete walls had strong angle cracks, indicating that there was probably foundation movement.

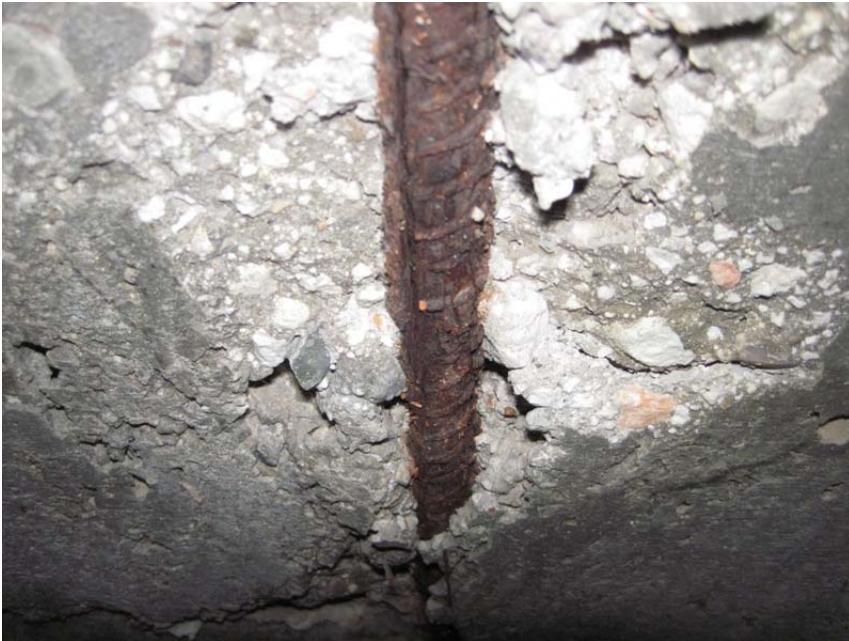
12 Exposed rebar and spalling on the ceiling of a classroom.

Many of the ceilings have exposed rebar and spalling concrete. Each time there is significant rainfall, more concrete spalls, and the rebar corrodes a little more.

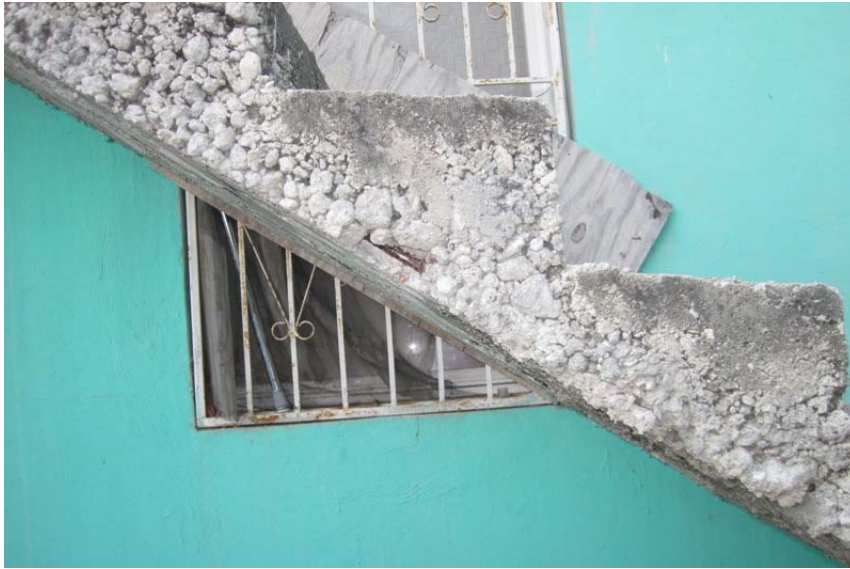
13 Exterior stairways with unconsolidated concrete and no guard rails are common in Haiti.

Many of the stairways have exposed rebar, spalling concrete, and unconsolidated concrete. These stairways often rely on columns to provide support. Usually, the support columns are not constructed to a higher standard than the stairway

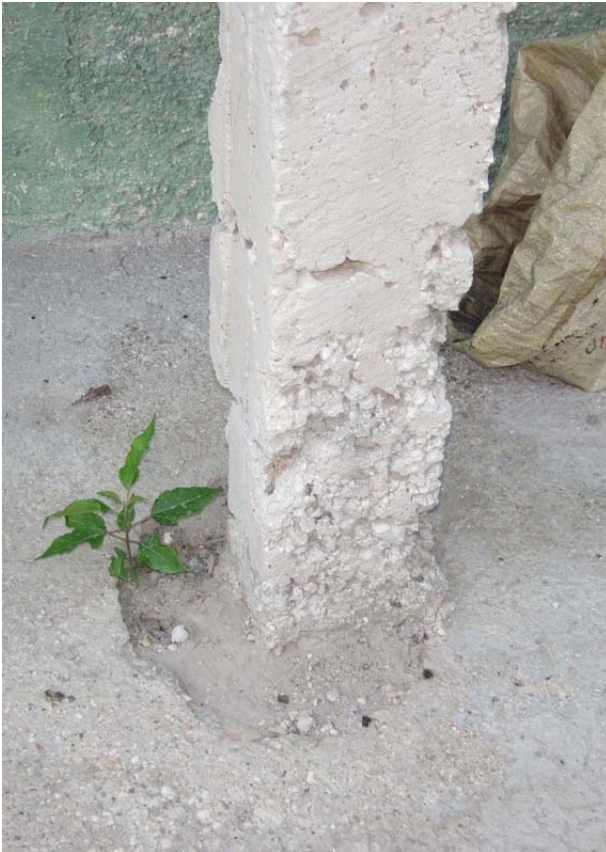
14 A concrete column supporting a flight of stairs shows signs of degradation.
