# *Lutheran World Relief Village Jacmel, Haiti*

By: Herb Nordmeyer  
April 16, 2018

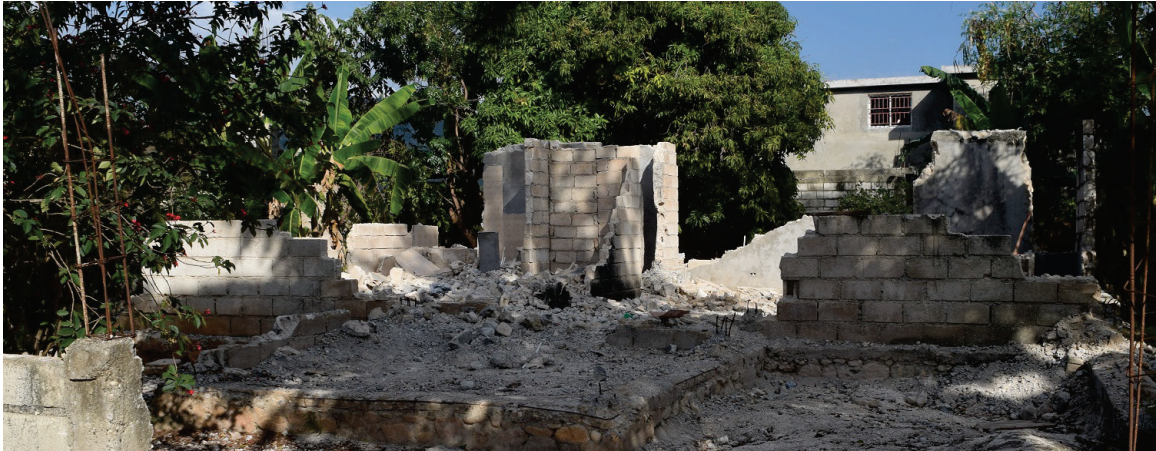
A damaged building from which the components are being salvaged.

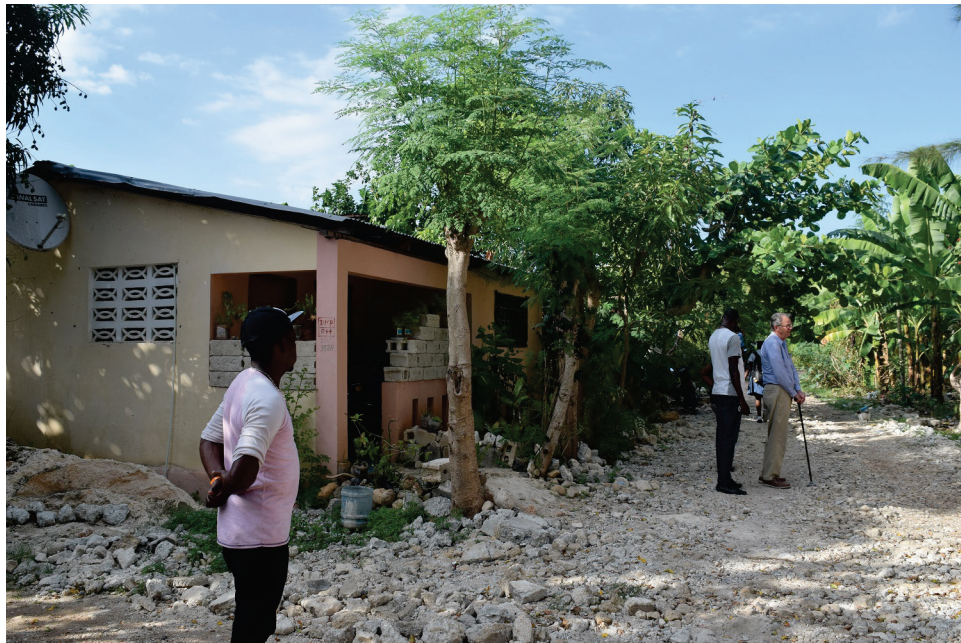
One of the streets in the Lutheran World Relief Village in Jacmel. The home to the left illustrates the simple yet solid structure of many of the buildings.

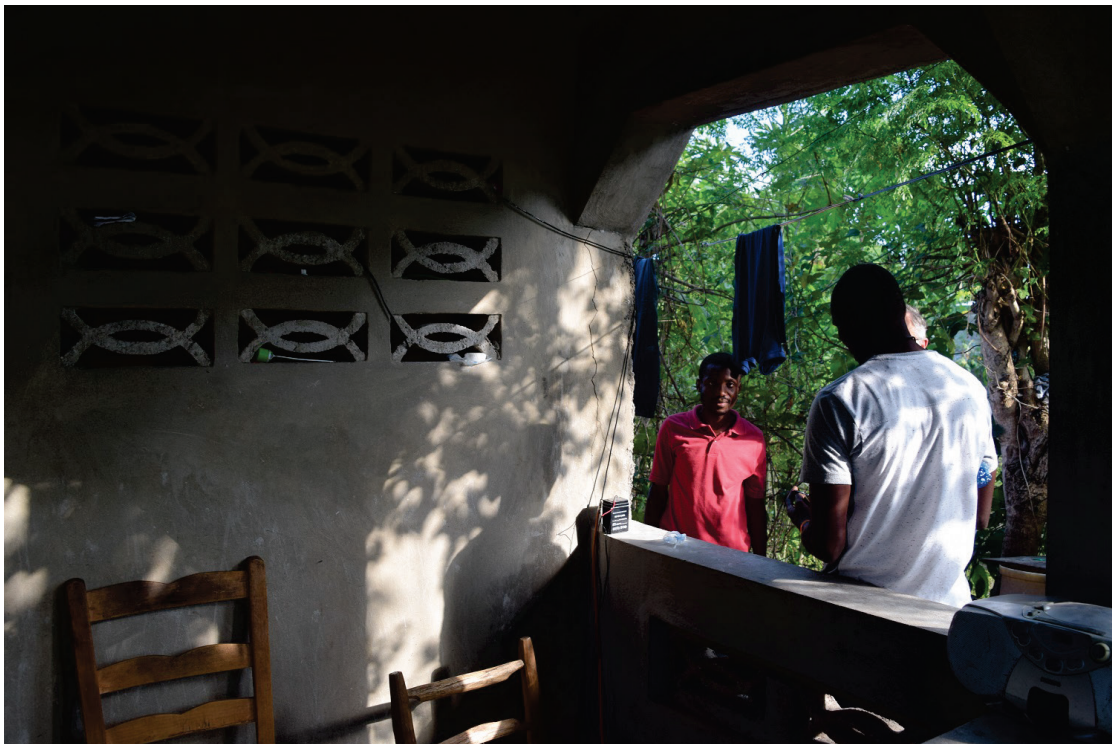
One of my students lives in this home. He asked me to look at some cracks. I did and then asked if he could explain them based on what he had learned so far in class. He did an excellent job.

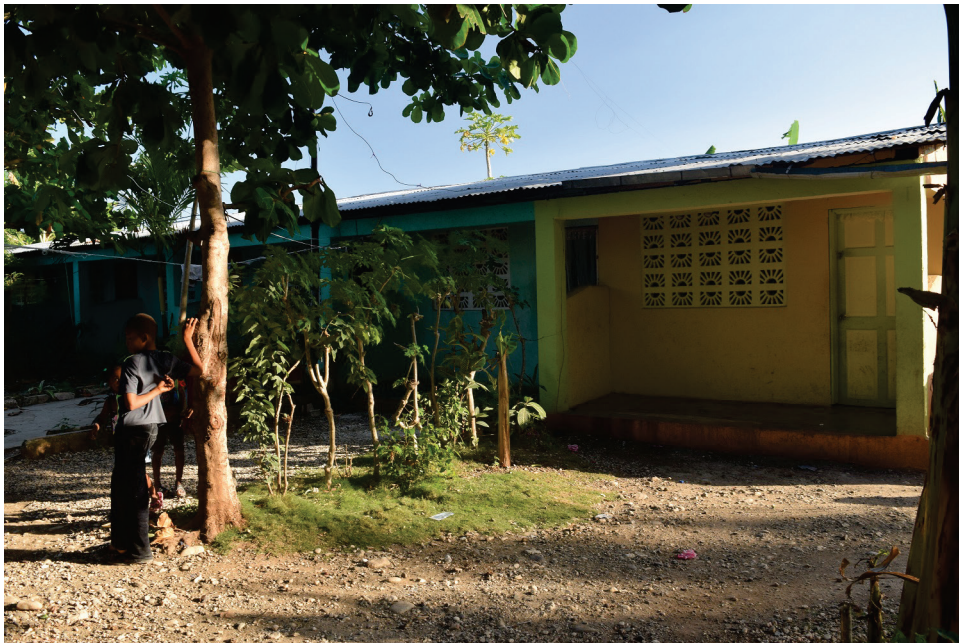
While many of the homes were single-family homes, some were row homes. There were also temporary wood homes which were erected after the earthquake which were still in use, since sufficient homes were not available to supply the needs of the area.

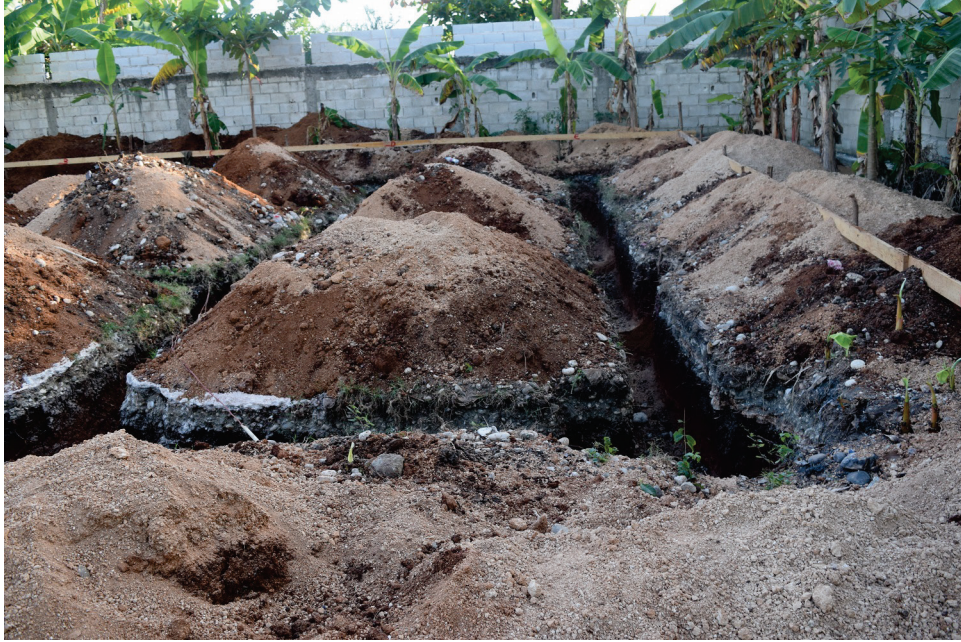
We entered the orphanage at the Lutheran World Relief Village and observed that foundation trenches were being dug for a new building. Some of the soil has a high clay content so the foundation needs to be deep.

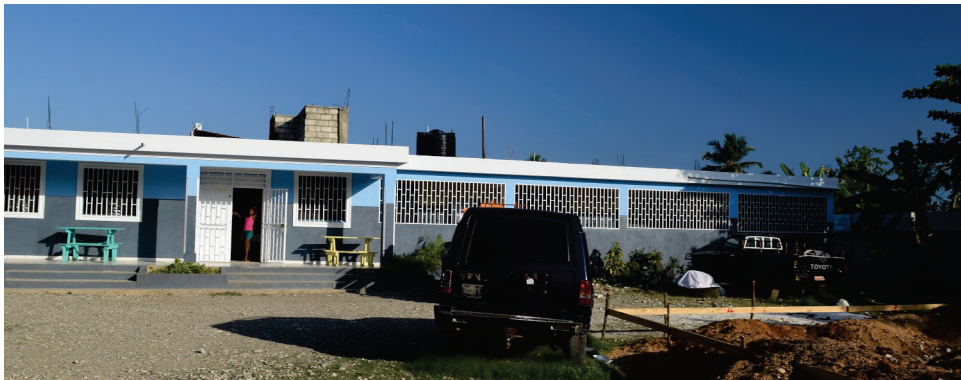
The main entrance to the orphanage at the Lutheran World Relief Village. To the right is the edge of the foundation trenches that are being dug for an additional building.

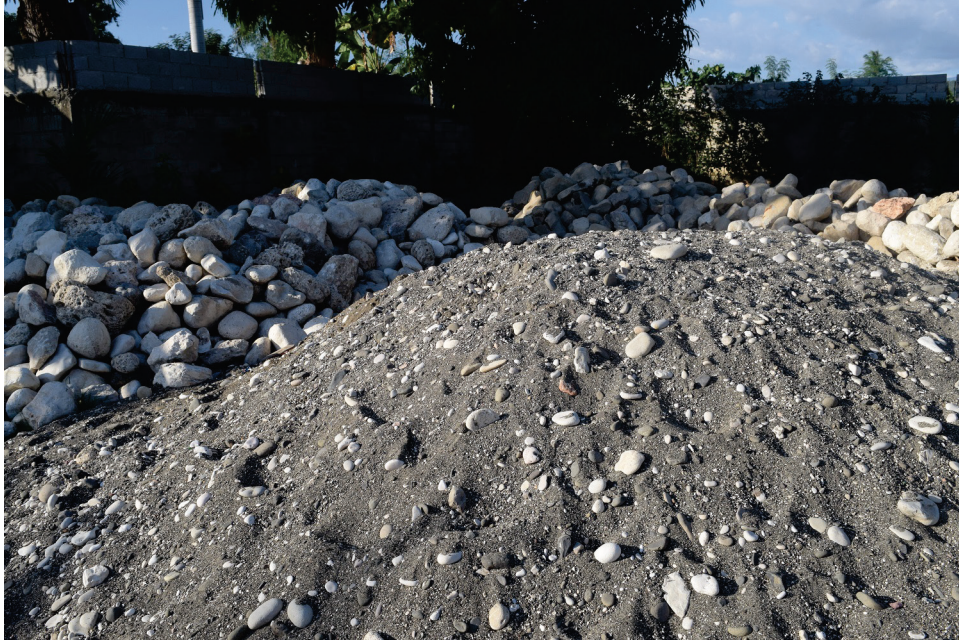
Gravel and stone stockpiled near the new building site.

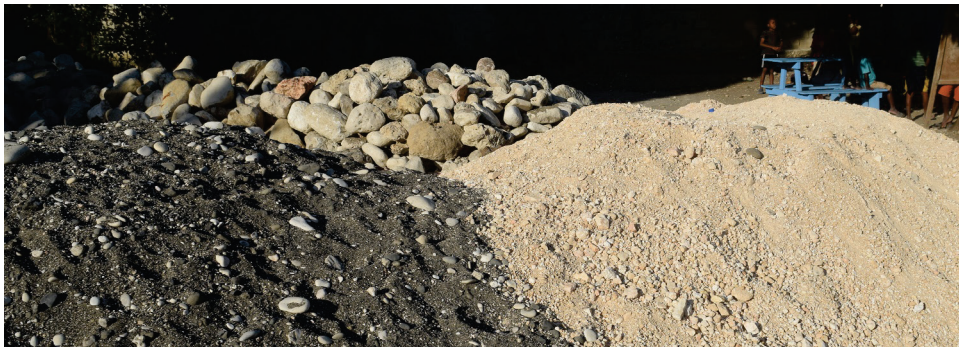
More gravel and stone stockpiled near the new building. The pile on the right is high in limestone and has considerable fines. If it is used as base material, it will serve well. If it is used in concrete, mortar, or stucco, it will result in an inferior product. The pile on the left consists of soil, sand, and large gravel. Due to the particle size distribution, it will make a poor concrete unless extra Portland cement is added to the mix. It would function well as a base material.
