# Concrete and Building in Haiti

## Corrosion, Chlorides, and Reinforced Concrete

Draft report as of November 14, 2013  
By Herb Nordmeyer

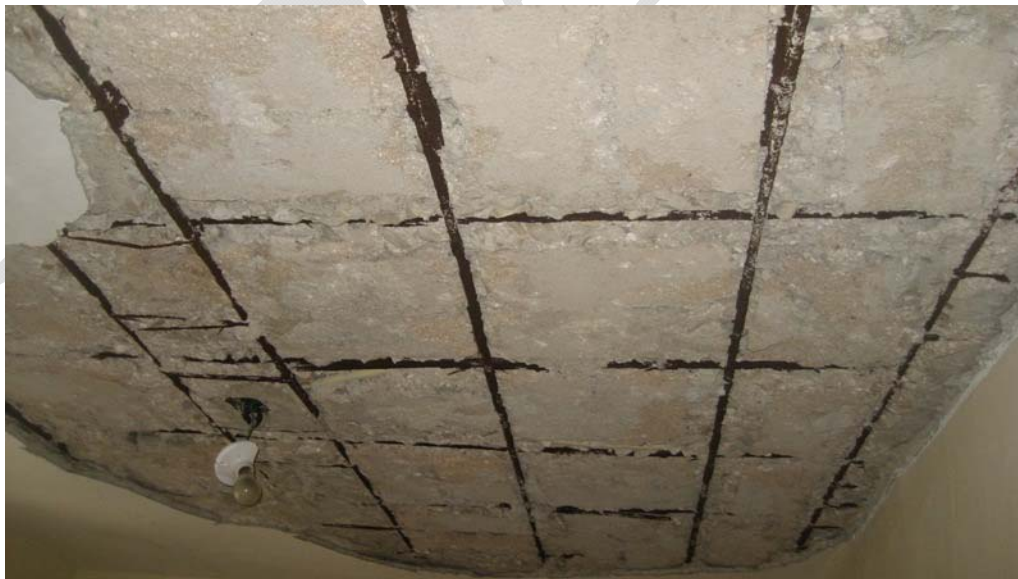
**Figure 1. The underside of a “flat” concrete roof in Gonaives, Haiti**

A survey of buildings in Haiti has revealed that much of the rebar is so corroded that it is damaging the concrete. In portions of Haiti, the water is brackish, and this accelerates the corrosion of the rebar. Very little stucco lath is used in Haiti; however, in coastal environments in the US, galvanized stucco lath has been observed to telegraph rust through the stucco within six months of application.
