Concrete and Building in Haiti

As of October 10, 2014

By: Herb Nordmeyer

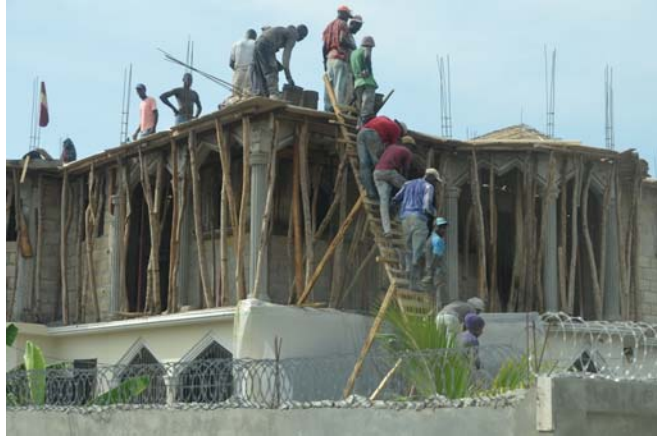
Figure 3. Pouring a roof on a 2nd story building.

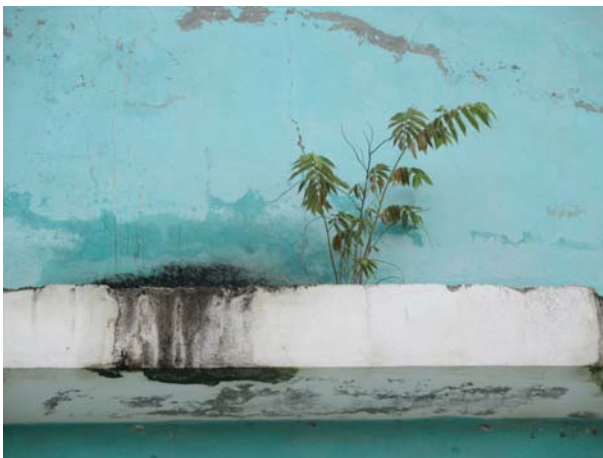
There was a tree growing from the second-floor slab.

Figure 4. A tree has taken root at the second floor slab which extends out from the wall.

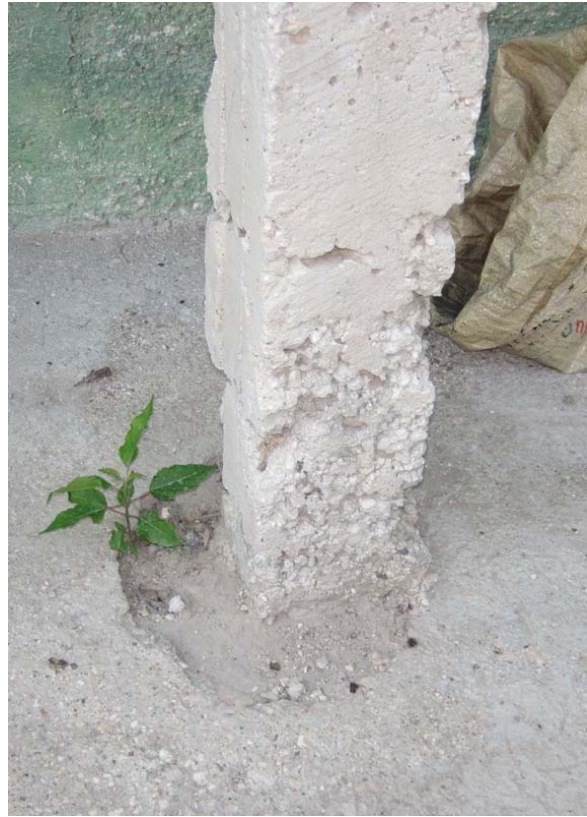
There was a support column with eroded concrete.

Figure 5. Support column with eroded concrete. It was holding up outside stairs.

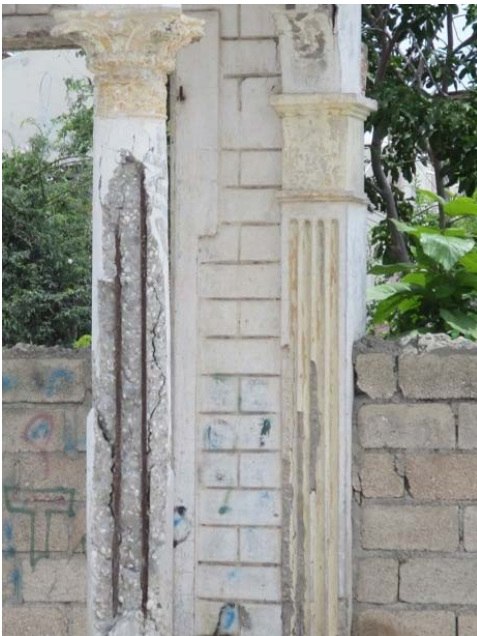
Rebar corrosion cracked concrete

Figure 8. Rebar corrosion caused the face
of the column to spall off.

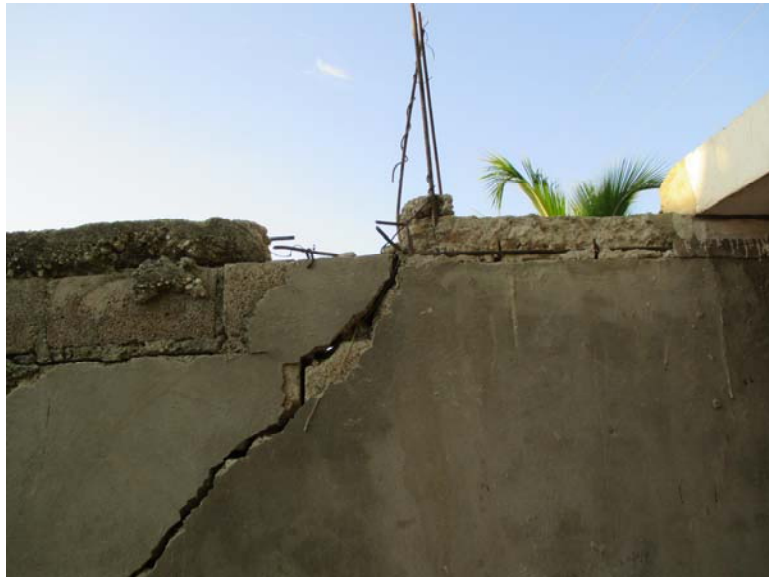
Faulty foundations caused fences to crack.

Figure 9. An inadequate foundation led to this wall cracking.

At each location, we discussed the cause of the problem and possible solutions. As we progressed, they started pointing out problems and leading the discussion.

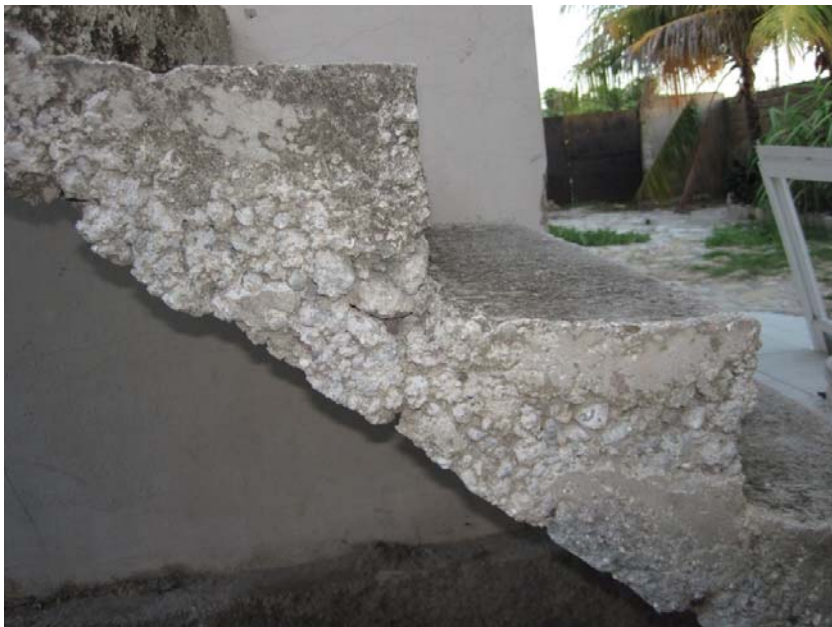
Towards the end of the field trip we looked at a set of outside stairs which had faulty supports, corroded rebar, and concrete with lots of voids. As I started up the stairs to the second floor, they stopped me and told me it was not safe.

Figure 10. Porous concrete used to form an outside stair.

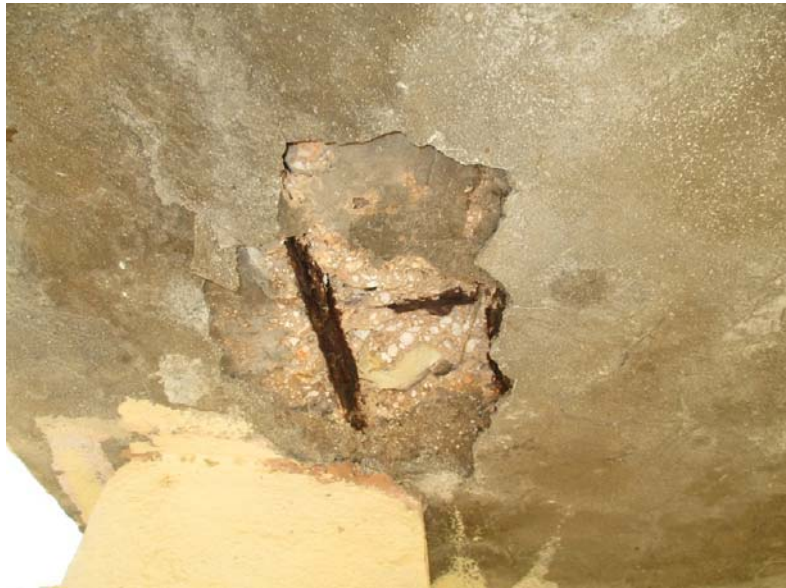
While at an orphanage, I was asked to look at an overhead concrete water storage tank. It had been taken out of service because it was leaking. Looking at it from a distance, I noted that three of the four concrete legs were not vertical and that there was no bracing between the legs.

Figure 15. Bottom of overhead water tank.

On the bottom of the tank, I noticed a hairline crack. I used the edge of my hand to hit the cracked area and a piece of concrete came off in my hand. It exposed the rebar which showed signs of deterioration. I then reached up and grabbed the rebar and it crumbled and came off in my hand. A decision was made to remove the water tank.

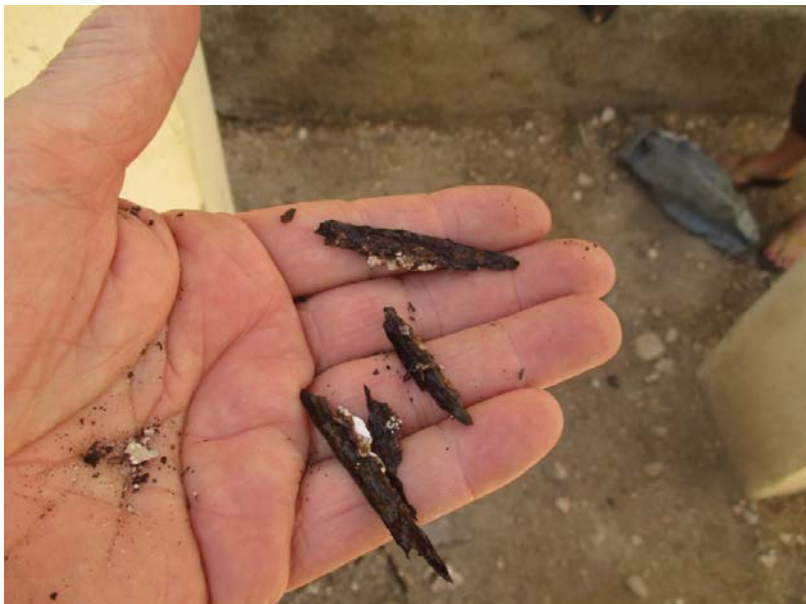
Figure 16. Corroded rebar from overhead water tank.

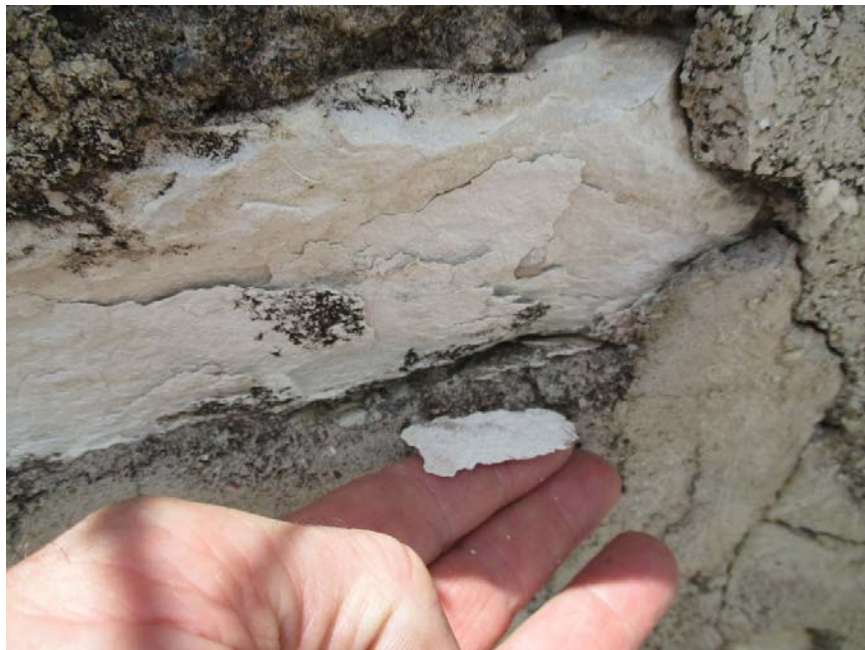
Some of the stones are deteriorating.

Figure 17.
Deteriorating stone
in sewer.

Around most of the stones, the concrete has shrunk and left an interface crack where anaerobic sewer water can penetrate into the concrete. After fewer than four years, there are

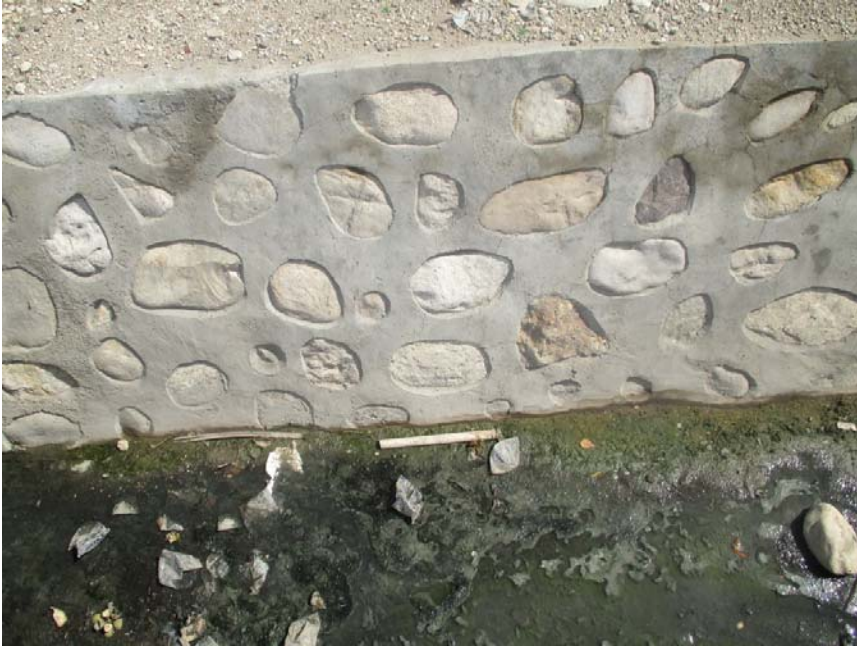
For years the sewers in Haiti have been open ditches. As they erode, they tend to destroy the streets along which they run. To eliminate this erosion, following the earthquake of 2010, many of the open sewers have been concrete-lined. The concrete for them has regularly used relatively large stones and left them exposed. This produces an impressive-looking open sewer, but it leads to some problems.

signs that the concrete is degrading. Even though concrete is used for sewer plants around the world, the concrete in Haiti is not holding up.

Figure 18.
Decorative
concrete in an
open sewer

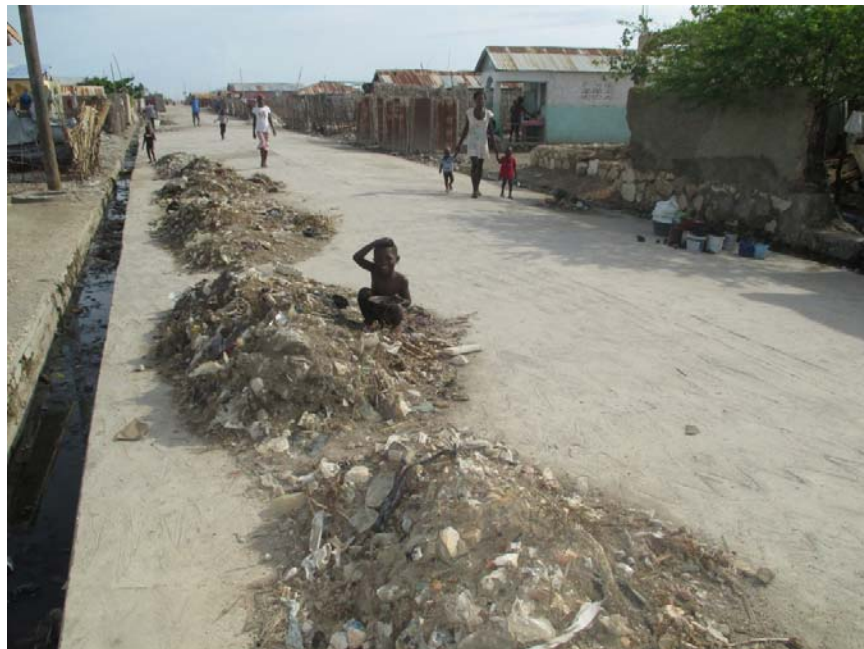
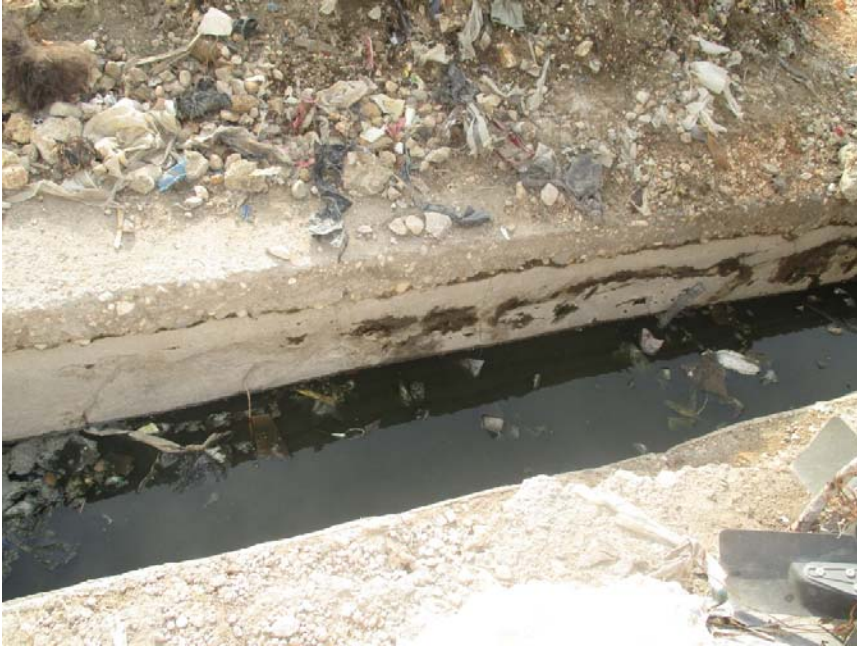
Within the past year, a new technique is being used to line the open sewers. Rather than sloped sides, a footing is poured and vertical walls are built with concrete block, and then the concrete block are plastered to protect them. While this system appears to be better, we have already seen deterioration in these sewers.

Figure 20. The new version of the open sewer.
