Haiti Report

Building the Candice Dominguez Girls' Dorm

Feb. 15, 2017 through March 3, 2017

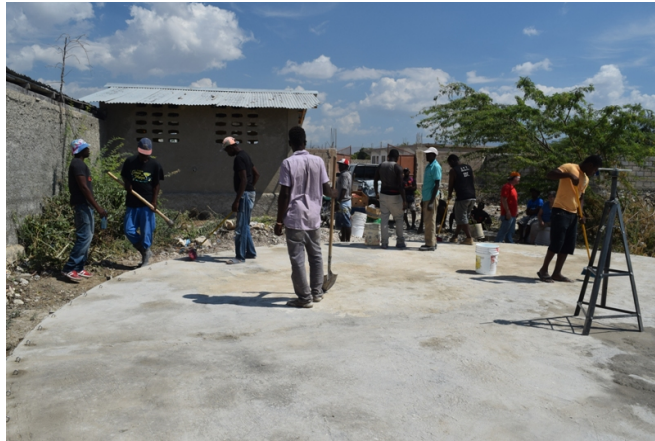
Rather than having seven experienced crew members, we had 11 men. One had worked on two homes and was competent. One had worked on two homes and was competent with close supervision. The crew chief was a real nice man, but not a leader. The rest were not experienced.

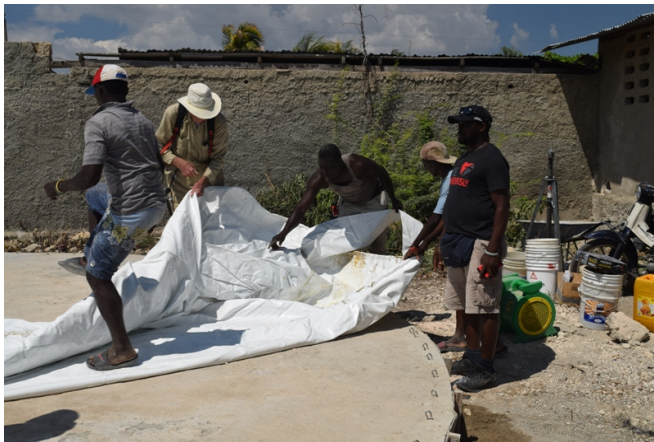
After the slab was cleaned off, we spread the Airform out and quickly realized we had picked up the 20-foot Airform rather than the 30-foot Airform. Switching them cost us about a 30-minute delay.

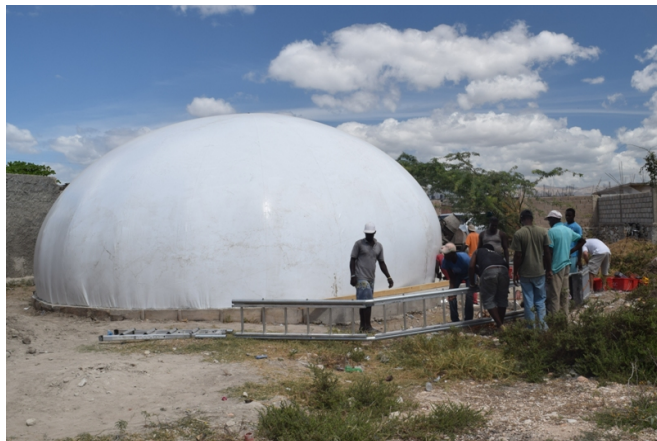
We finished attaching the Airform and got the center tripod in place. While doing this, Scott Conover and Benjamin got parts to attach the bypass valve to the line from the blower to the Airform. We attached the bypass valve and the manometer. Shortly, the air pressure was up to 5.5 inches of water.

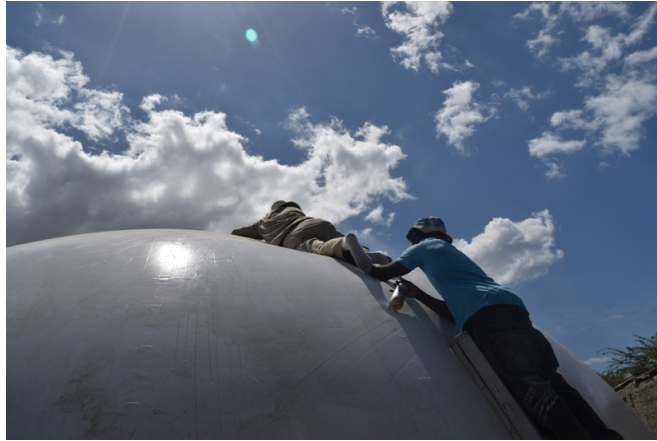
We then erected the polar scaffold. It involved me climbing up onto the Airform. So I would not damage the Airform, I took my boots off. I should have taken my socks off as well. Using an eight-foot ladder leaning against the dome, I got up as far as I could, but could not get the traction I needed to continue. One man came up the ladder and gave me a boost until I got to the point where I could get traction to continue my climb. He was on the top step or next to the top step of the ladder when I got traction.

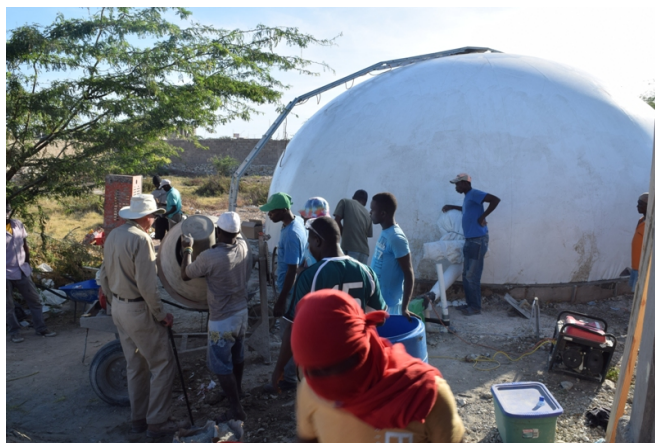
Gasoline was added to the tank, but the motor would not start. Based on the odor, gasoline had been left in the tank and had turned to varnish. The carburetor was plugged. Rather than causing a delay while trying to clean the carburetor, we rented a mixer so we could get started.

When the mixer arrived, I explained to the owner (he operated the mixer) how we needed the concrete mixed and assigned the man I had just trained to help him.

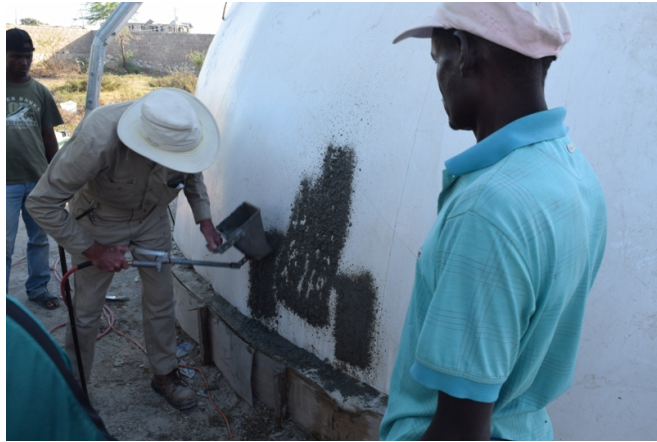
Before we started spraying, I explained how the Mortar Sprayer worked and how it would produce a concrete coating that was better consolidated than a coating applied with a trowel. Further, I explained that we needed to apply the first coat approximately 1.25 cm thick. As a result, we needed the concrete mixed as thick as possible and still spray it. Everyone stated that they understood.

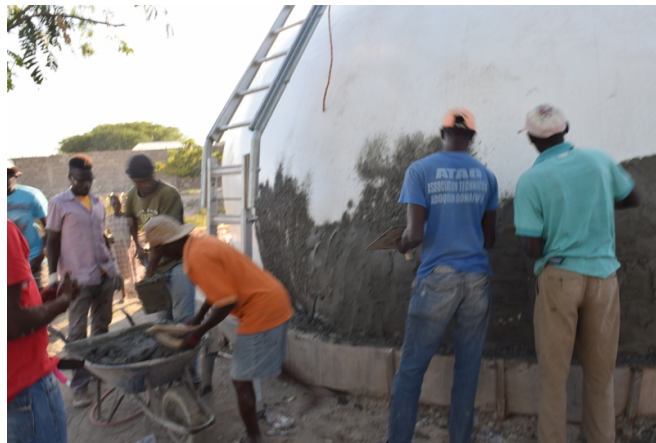
Others started smearing stucco on the Airform with their trowels. Since the concrete was stiffer than they preferred, they added water and told the man on the mixer to add water to get the consistency right. For the rest of the construction project, I fought to keep the water level as low as possible. I would stop the crew and explain again, using an interpreter so there was no chance of misunderstanding.

They would listen and go back to doing it the way they had been doing it. Within 15 minutes, there were signs of sagging. Within 30 minutes, cracks were showing up.

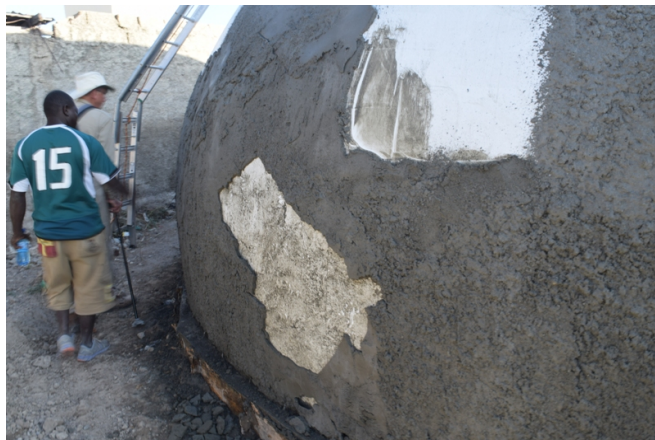
The concrete which had been applied with a trowel was in very poor condition. In some areas it had fallen off. Most of the rest of it was cracked.

I took the crew around and showed them the cracks, the sagging, and the places their stucco had fallen off the Airform. Then I showed them the areas that had been sprayed but not troweled. There was only one minor crack in that area. I explained that we wanted to build a structure that would hold up and last for decades, and if they wanted to build a structure that would not hold up when the Airform was removed, we might as well stop right now. I pulled a piece of concrete free, and a piece 4 feet long came off.

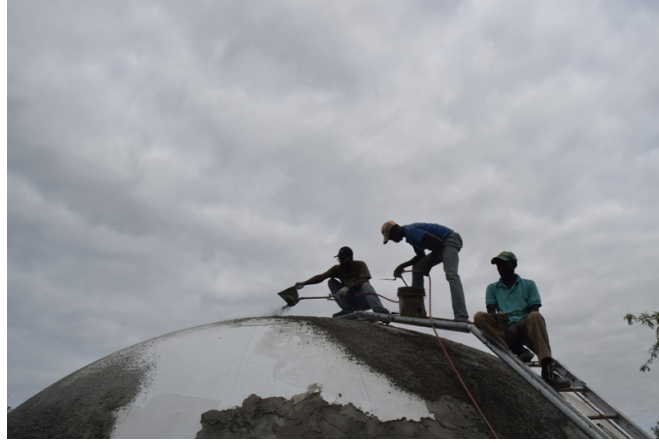
In moving the polar scaffold, the two ladders had to be moved in conjunction with each other. This seldom happened, and they ended up being twisted. We had to take the ladders down and straighten them. To keep the same problem from happening again, we used self-tapping screws to affix the chain-link fence post to the EMT joints.

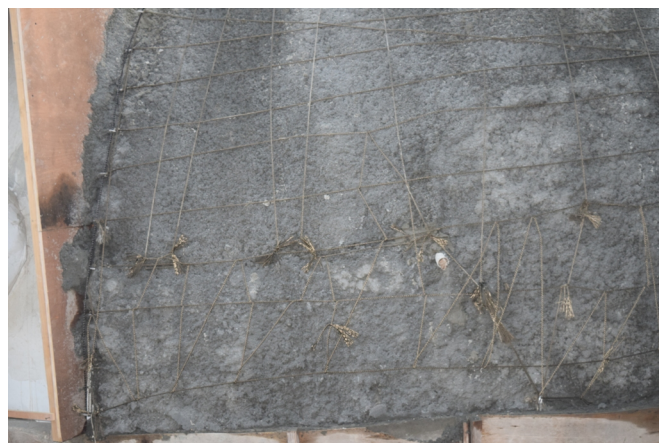
By quitting time, we had the first coat of stucco on and the dome half-wrapped. The wrapping process was difficult for me since the crew could not understand the wrapping process. When wrapping over the top, it was necessary to come down, hook on one of the hooks, move to the next hook and then go back over the top. Part of the crew would go back over the top without moving to the next hook. On the other side there was a tendency to skip hooks. This resulted in numerous areas that had too much basalt rope and other areas that did not have enough. I ended up having to walk around the dome with each piece of rope that was carried over the top.

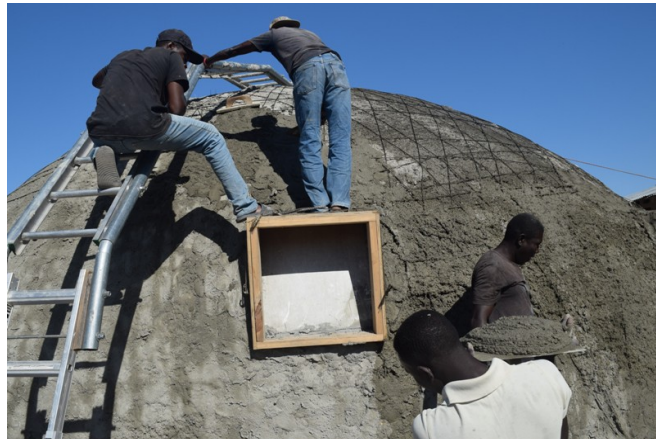
The crew stated that applying the plaster with the Mortar Sprayer was too slow. They wanted to trowel-apply the second coat of concrete. I insisted that the Mortar Sprayer be kept in operation, but allowed those not operating the Mortar Sprayer or feeding it, to throw stucco on with trowels if they used considerable force and did very little troweling. I requested that the second coat be not less than 5/8-inch thick and preferably 3/4-inch thick.

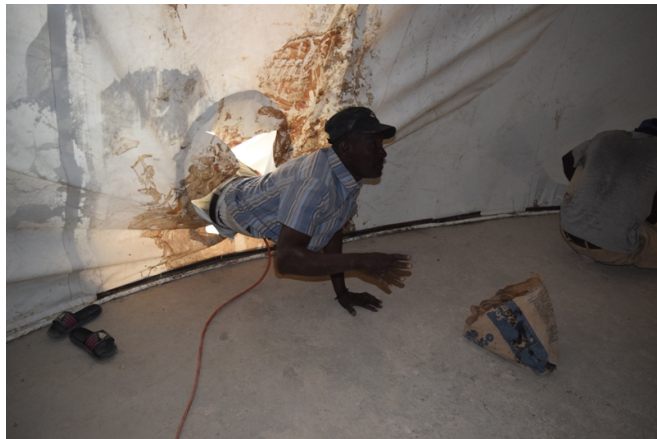
When we arrived, the blower was off as instructed, and the Airform was deflated. It had not stuck to the inner surface of the dome as is usually the case, so we had to reinflate the Airform to get inside and remove the Tapcon anchors and the clamp angles.

To get into the Airform, one must crawl through an 8-foot tube and lose one's

dignity. The crew referred to the tube as the birth canal.

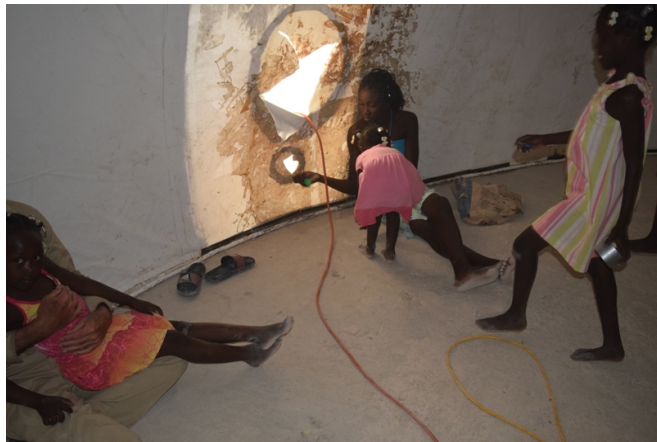
We invited the young ladies who would be living in the Girls' Dorm to come inside as we were working. They loved it, especially holding bottle caps in front of the air inlet and letting the air blow the bottle caps across the slab. Before we deflated the Airform, we sent the girls out.

With the blower still running, we staged everything that was to leave the Airform near the door away from the blower. We lifted the edge of the Airform and everyone exited as the Airform gently came down.

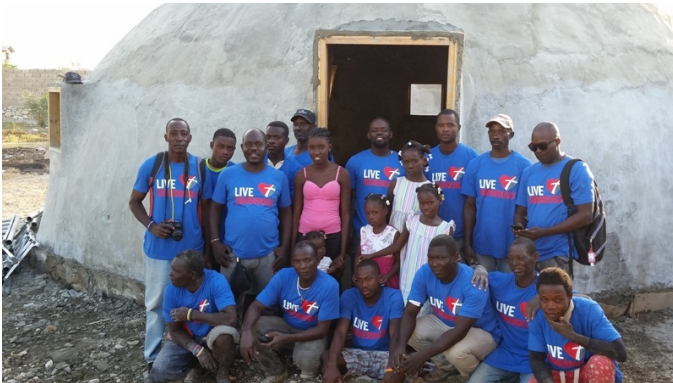
I taught two of the crew to mix whitewash and to apply

it. Before we left, the bottom 8 feet of the outside of the Airform had the initial coating of whitewash. The plaster on the inside was too fresh for the application of the whitewash.
